Property Line Contamination Issues and Associated Risks to Buildings plus Cross-Contamination Issues & Water Supply Protection

Joseph E. Odencrantz
(Principal and Owner, Tri-S Environmental, California, USA)

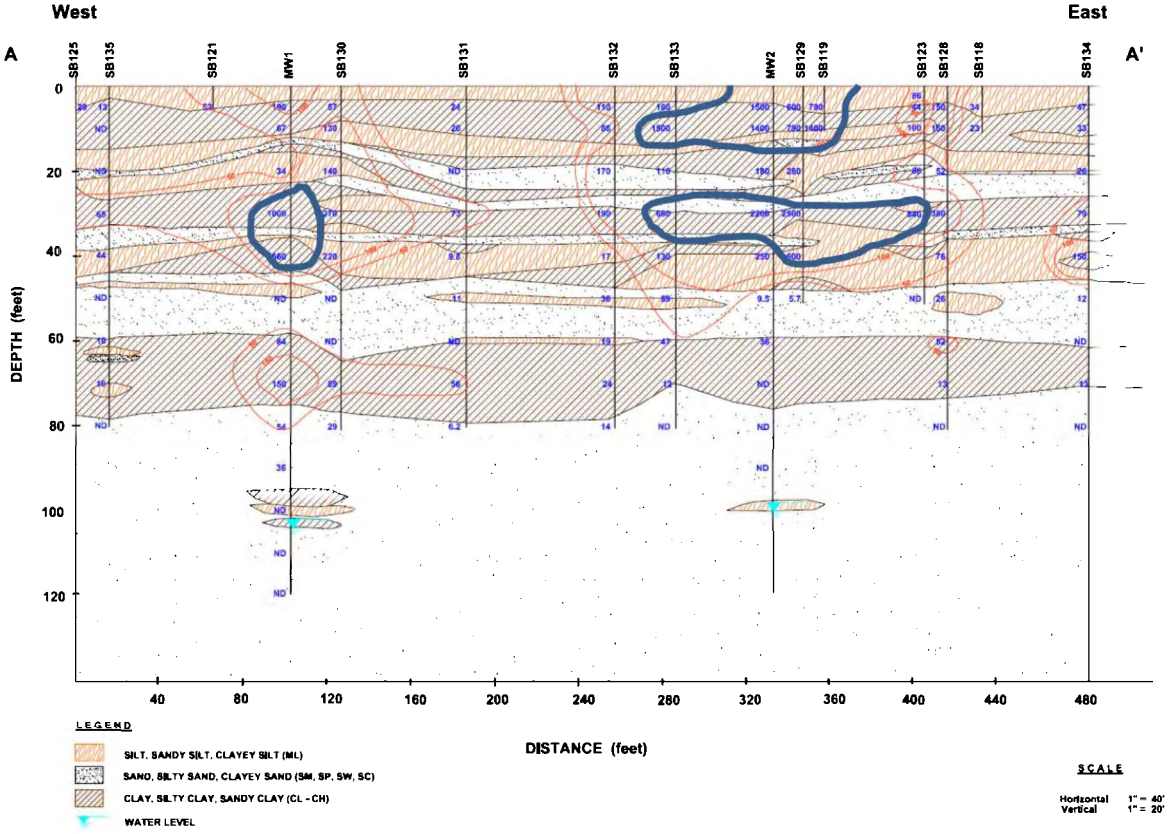
Figure 1. Cross-section of PCE contamination with depth (ug/kg) approximately 35 feet (10 m) north of the property line of the subject site. Bolded lines/shapes represent the 500 ug/kg contour lines.

In the year prior to the consultant performing the due-diligence for the prospective property owner, an investigation report was published (public domain and available at a local environmental regulatory agency) for the site to the north of the property line which contained Figure 1. The investigation report also discussed the site revitalization and decommissioning plan that was slated to take approximately one year. This site was a large battery manufacturing facility, in business for over 40 years, midway through the process of decommissioning at the time the subject property owner's consultant was reporting on the subject properties due diligence investigation. The consultant did not report this information to the prospective property owner but focused his investigation on residual PCE from a former clarifier on the subject property that was investigated, remediated (by vapor extraction) and closed by the regulatory agency twelve years earlier. The consultant proposed and performed an

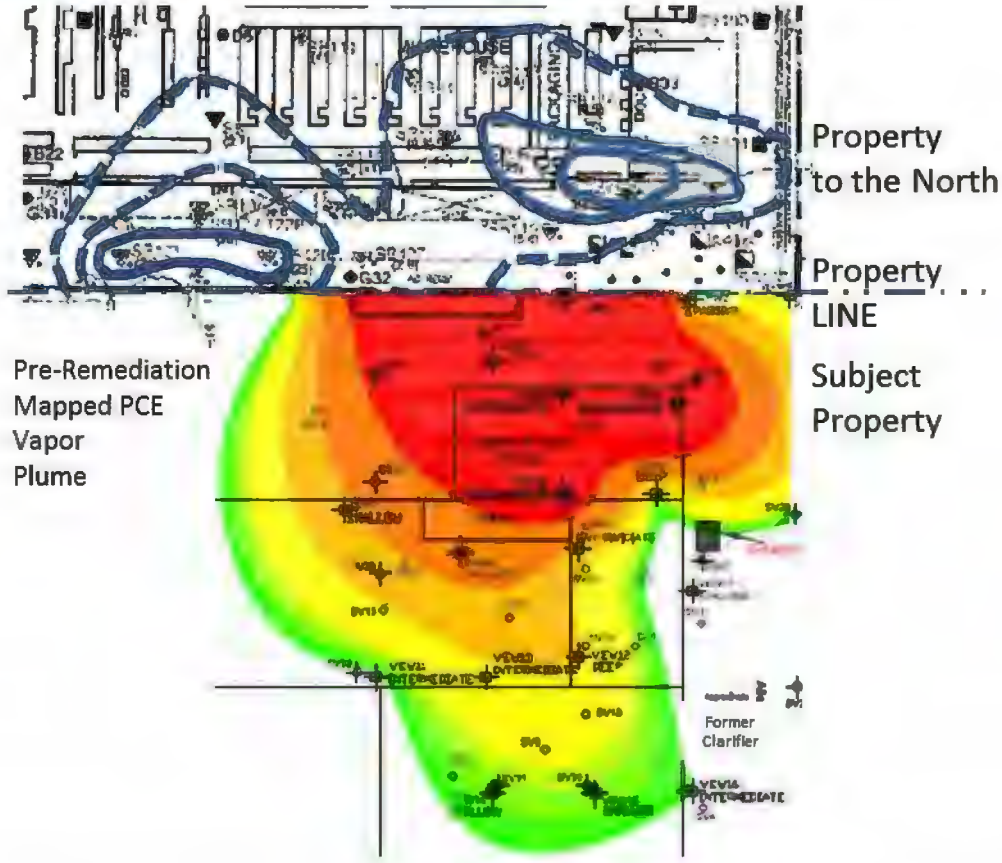
Figure 2. PCE vapor plume depicted by each property owner's consultant prior to vapor extraction on the subject site owner's property. The red color indicates a maximum PCE concentration on the subject site of approximately 200 ug/L.

Table 1 contains the PCE concentrations in soil on the site to the north, as a function of depth and distance from the property line, and the resulting soil vapor concentrations on the subject site. Figure 2 shows the contours of PCE vapor on the property to the north at five feet below the surface prepared by their consultant and the pre-remediation vertically averaged PCE vapor contours on the subject site (5 to 60 feet below the surface) prepared by the consultant to the subject site owner. The full vertical extent of contamination on the property to the north is shown in Figure 1. The consultant for the subject site convinced the new property owner that the site would be cleaned up with relative ease and within a year after the property owner's purchase of the site. As you can see by the consultant's own depiction of the PCE vapor plume in Figure 2 in red, the PCE is clearly emanating from the property to the north of the property line. The former clarifier on the subject site is mapped near the bottom tip/green portion of the plume and clearly not the source of PCE vapors on the subject site.

The consultant to the subject site owner was unable to remediate the subject site to regulatory limits after four years of remedial activities using vapor extraction because the source of PCE vapors was located on the other side of the property line. The consultant kept promising his client that cleanup would be completed with more time and money. That did not happen and after approximately four years, the property owner realized that something was amiss with the situation. The local regulatory agency will not close the site until the remediation is completed, which is now contingent upon indoor air concentration limits of PCE. In addition, the regulatory agency is requiring that other VOCs to be reduced below strict standards for human exposure. The project is now in a state of flux and the property owner is considering suing the property to the north for cost recovery and to assume the responsibility for site cleanup. The consultant for the subject site was released of his duties and the property owner hired a competent and ethical environmental professional to assume oversight of the cleanup strategy.

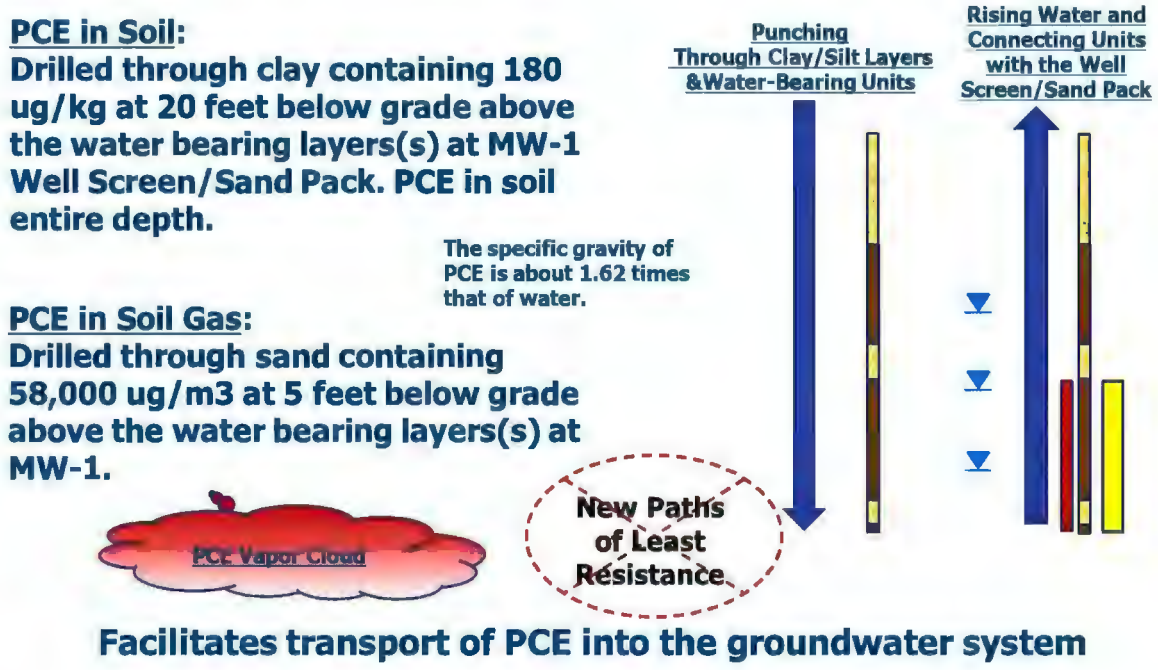
Figure 3. Potential Problems When Drilling Through PCE in Soil/Soil Gas.

The consultant's next step in the site characterization process was to collected groundwater hydropunch samples in the shallow groundwater using a Geoprobe® direct-push drilling technology. The consultant drilled through both the elevated PCE soil gas concentrations in the shallow soils and the PCE concentration of 180 ug/kg at 20 feet below ground surface until they reached the shallow-most groundwater. First groundwater was encountered at approximately 28 feet below ground surface. Upon reaching the groundwater regime, the water rose up the hole created by drilling to approximately 17 feet below grade. The water was under pressure (confined/semi-confined) and rose thirteen feet in the borehole. There are multiple problems created by this investigatory method: a. dragging down of PCE vapor into groundwater, b. dragging down of soil cuttings that contain PCE into groundwater, c. the cross-contamination of groundwater that rose up within the borehole with PCE in the soil column (groundwater water may have not been impacted with PCE prior to the drilling activities. ASTM D6724-04 (2010) Standard Guide for Installation of Direct Push Groundwater Monitoring Wells provides excellent guidance and states "For direct push methods to provide accurate groundwater monitoring results, precautions must be taken to ensure that cross-contamination by "smearing" or "drag-down" (that is, driving shallow contamination to deeper levels) does not occur, and that hydraulic connections between otherwise isolated water bearing strata are not created."

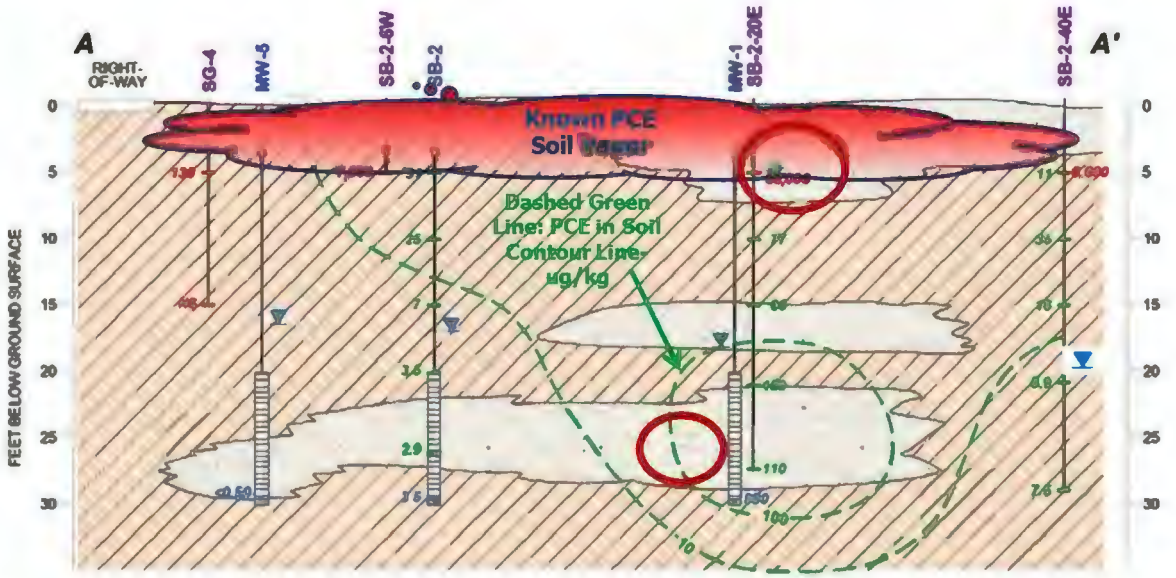
Figure 4. Well Screens/Sand Packs at MW-1 Now Potentially Allow PCE In Soil/Soil Vapor To Enter The Ground Water System. The red circles are key depths near MW-1.

The consultant reported 890 ug/L of PCE in the groundwater at MW-1, which is a one-inch diameter well with a screen from 20 to 30 feet below ground surface. The installation of this monitoring well allows the PCE-impacted soil to continuously impact groundwater via dissolution from the soil matrix into the water phase. It is also now virtually impossible to determine whether the confined groundwater below 25 feet below grade was previously impacted with PCE. The consultant reported this 890 ug/L to the local water regulatory agency and the agency required additional groundwater characterization as a result of this finding. The agency also required the consultant to install either two- or four-inch diameter monitoring wells and the consultant for the City who donated the property strongly desired alternative drilling plus insisted on improved well construction techniques.

The future drilling at the site required a conductor casing (sometimes referred to a surface casing) be installed prior to the installation of groundwater wells in these shallow PCE source area zones to minimize the potential for cross-contamination. The groundwater monitoring wells are to be screened only in the groundwater bearing zone, in this instance 28 to 33 feet below ground surface, with short, targeted well screens that are isolated with a plug (seal) on top and bottom of the well screen (Note: Detailed lithology contained in the well/boring logs and not reflected in the general cross-section shown in Figure 4). The previously installed well screen for MW-1 was ten feet long and provided a conduit for future recharge of the groundwater system with PCE. MW-1 was abandoned by over-boring and then grouting prior to the installation of the future groundwater wells in the vicinity. In order to protect the water supply (the main groundwater aquifer below this site), preventive measures are a necessity to alleviate any future migration of PCE (and any breakdown products) into the perched, confined water-bearing zone and main aquifer.
