Re: Preliminary Conceptual Site Model Addendum 1551 East Orangethorpe Avenue, Fullerton, California Geotracker Global ID# SLT8R2213999

Roux Associates, Inc. (Roux Associates), on behalf of Arnold Magnetic Technologies Corporation (Arnold), submits this Preliminary Conceptual Site Model (PSCM) Addendum (Addendum) as requested in the Santa Ana Regional Water Quality Control Board (SARWQCB) June 14, 2019 *Comments on "Preliminary Conceptual Site Model" for Former Arnold Engineering Facility (a.k.a Fullerton Business Park North) at 1551 East Orangethorpe Avenue, Fullerton, Orange County (comment letter).*

Figure 1 – Site Features

Figure 2 – Areas of Concern

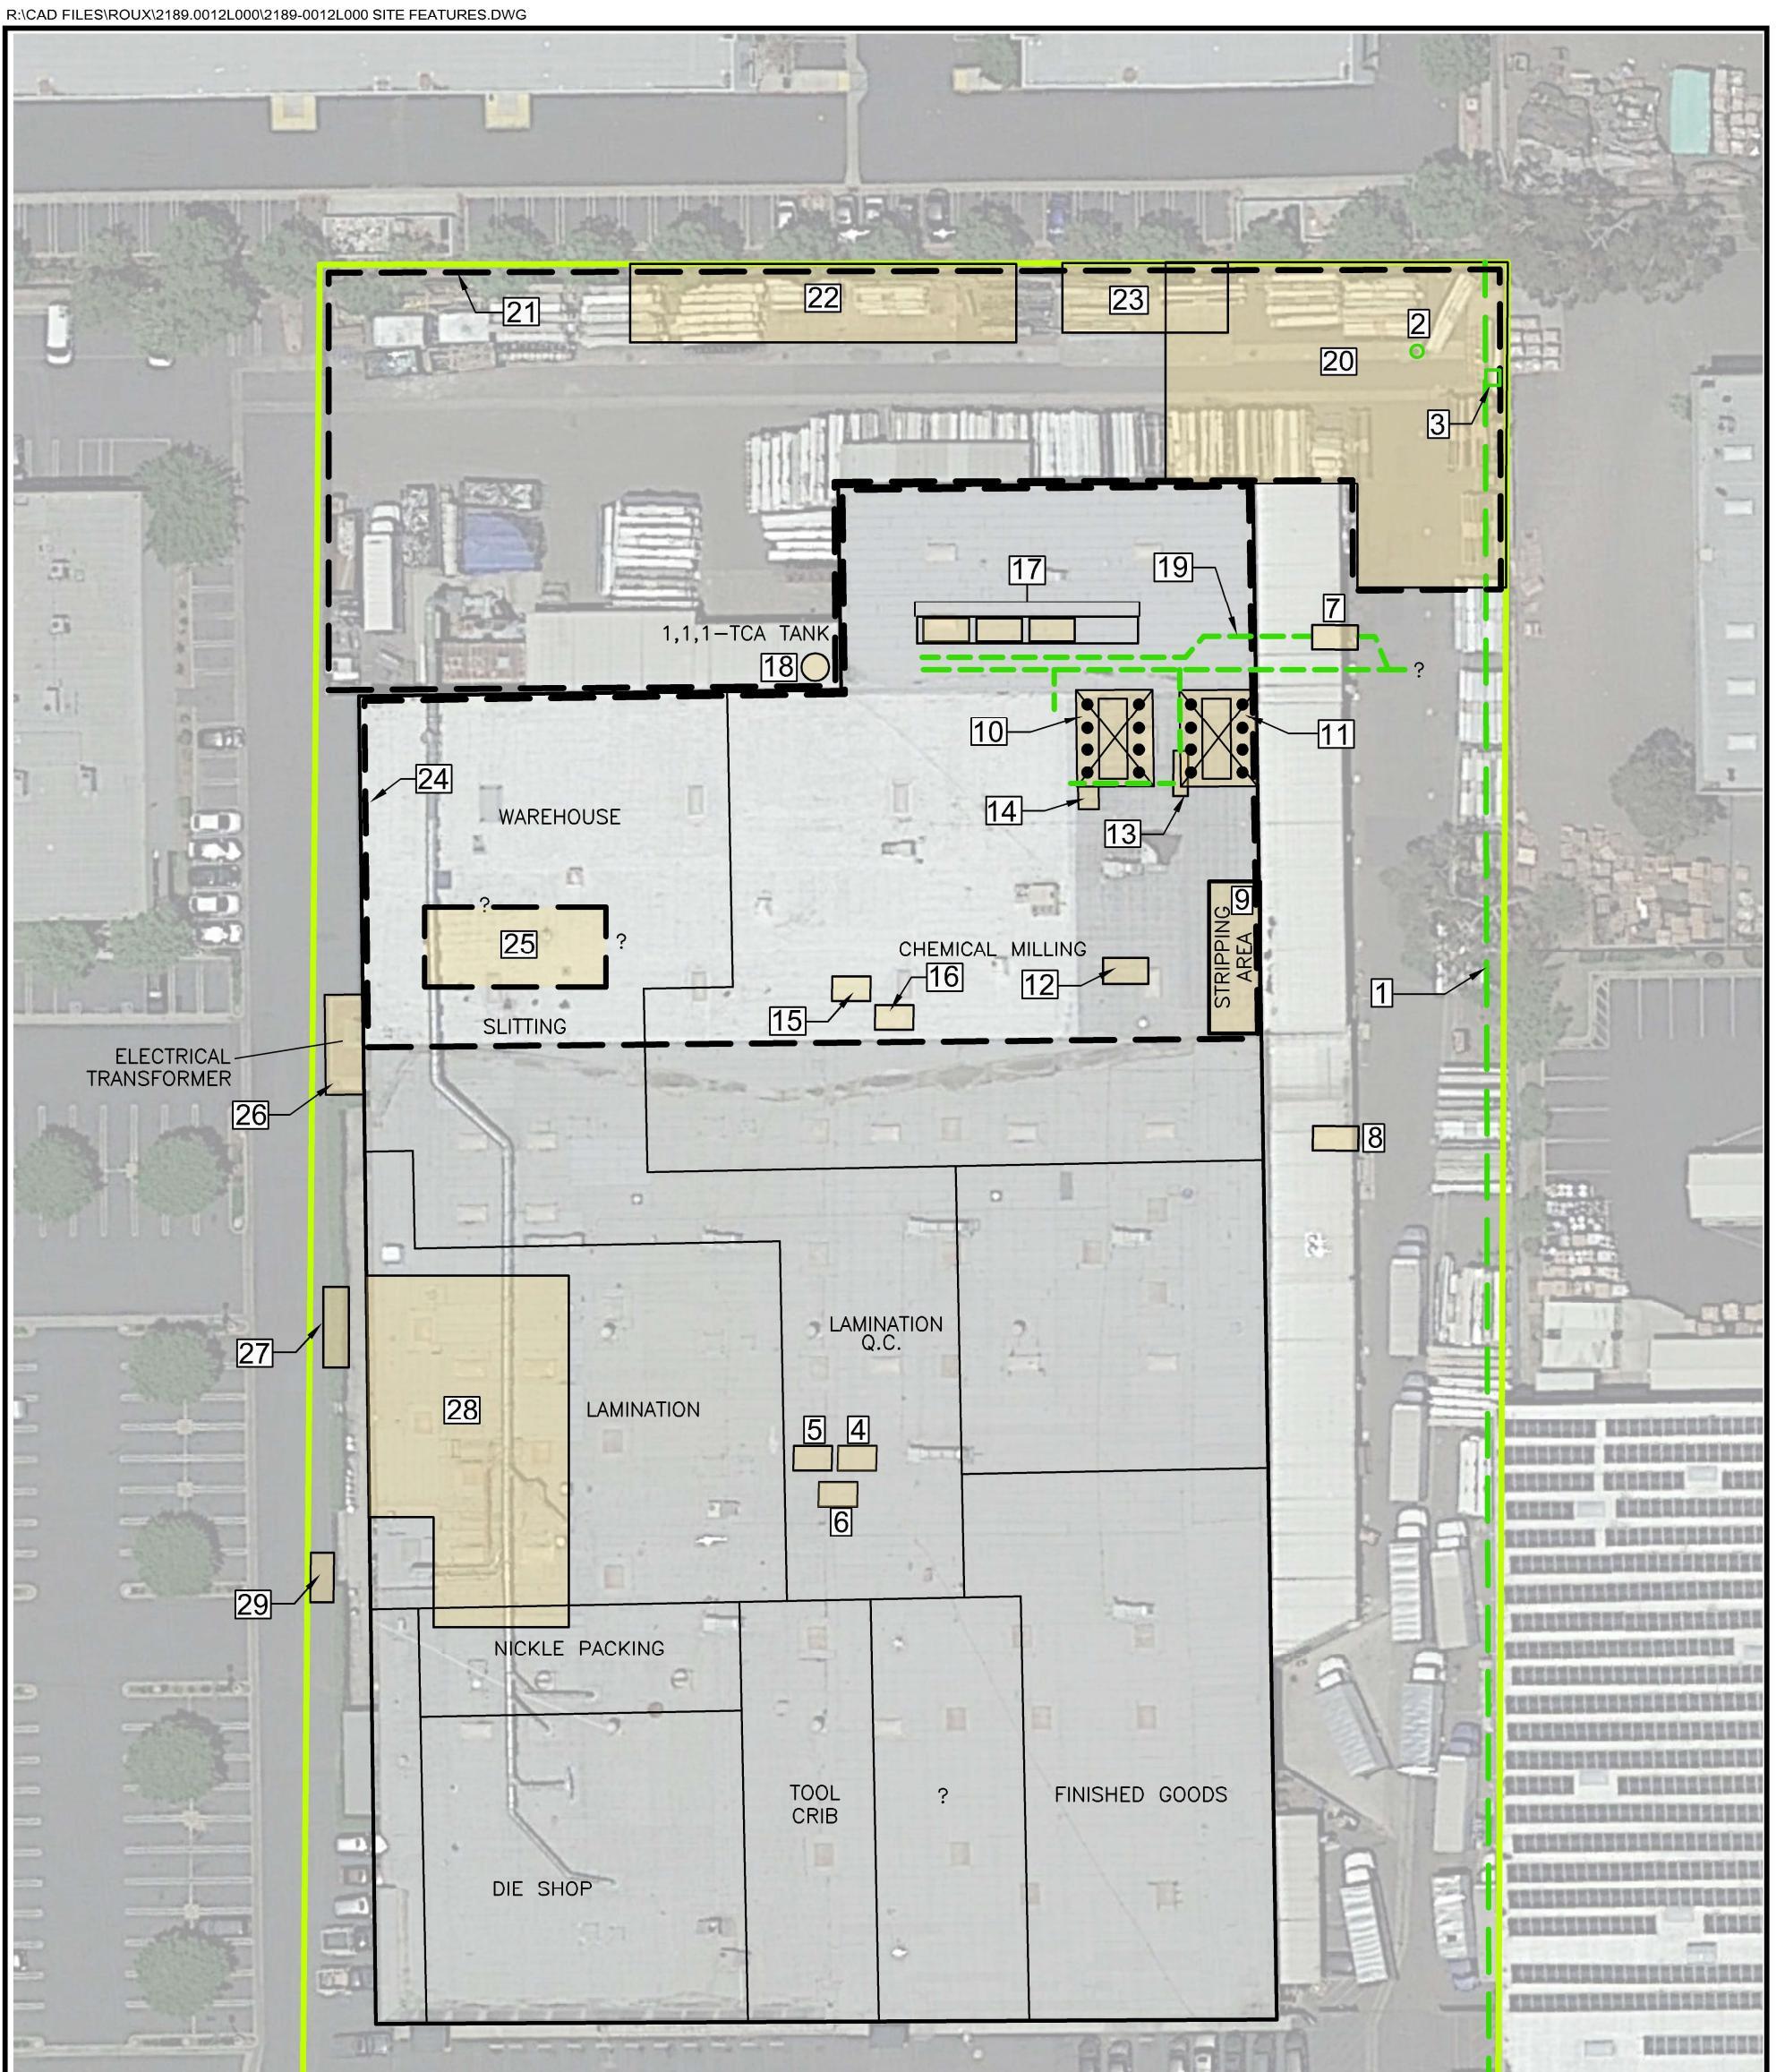
The AOCs and Site Feature locations shown on Figure 1 and Figure 2 are approximate and based on various sources as listed on Table 1. As discussed further below, very few Site Features could be located/verified during the Site walk, and this is primarily attributed to current Site operations and substantial Site remodeling and/or alterations which have occurred in the more than three decades since Arnold operated at the Site, some made within the last decade. Some of the sources for the location of Site Features have unknown authors/origins; are undated; and/or, are partially illegible. Based on all of these factors, the level of approximation for each location varies significantly as discussed in the "Location" column of Table 1. Some Site Features have more than one source and the locations and information on the sources do not always match. Additionally, the two rounds of SVE at the Site (1995 and 2008-2011) and the SVE remedial efforts of Johnson Controls to the immediate north in (2006-2007) have reduced the mass of VOCs in the vadose zone; and altered the distribution of subsurface contaminants.

Based on the current level of Site activity and congestion and the plans for equipment and materials relocation in the near future, it is recommended that a work plan be prepared for the shallow soil vapor investigation as described in the following updated Section 6 *"Data Gaps and Recommendations"* using the AOCs and Site Features in Table 1 and on Figures 1 and 2. After removal of the International Window
