ELEVATION CROSS-SECTION L-L'
COUNTRY CLUB VILLAS
LAGUNA NIGUEL, CA

Tri-S ENVIRONMENTAL
WATER AND LAND OFFICES
 3151 Airway Avenue, Bldg. H1
 Costa Mesa, CA 92626
 www.tri-s.com

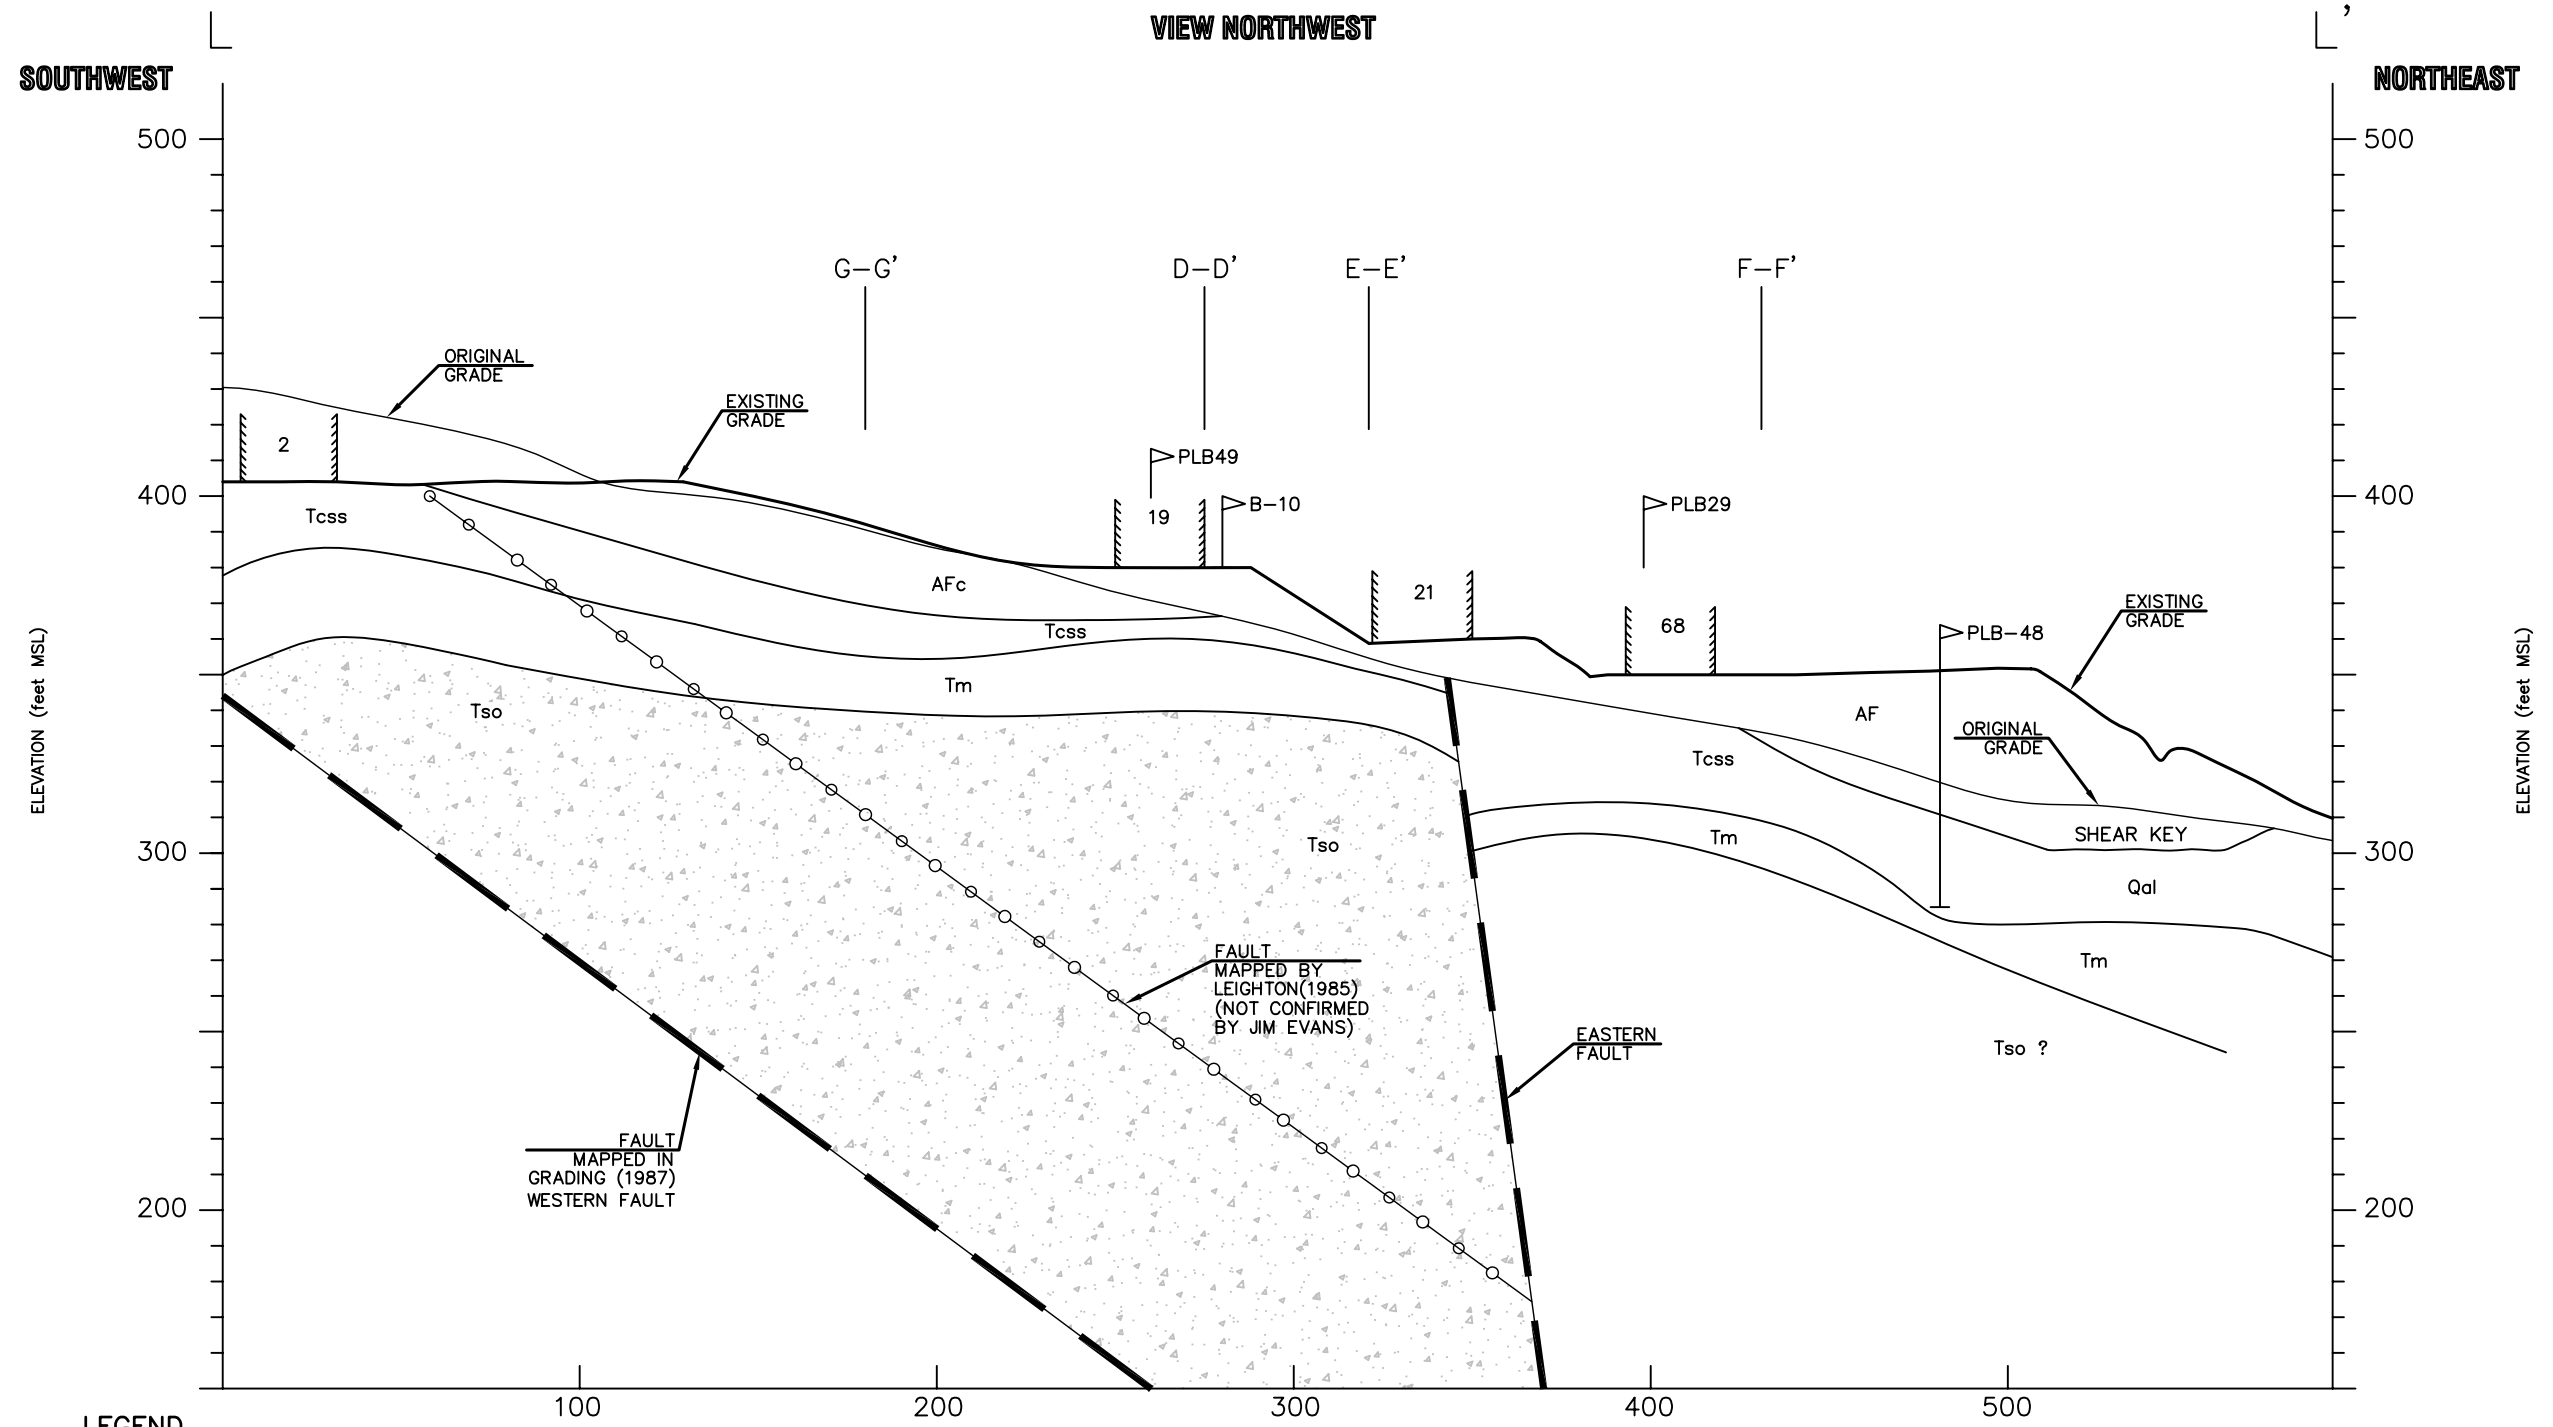
NOTE: ALL DIPS SHOWN ARE APPARENT
